SAFEX
INTERNATIONAL
(Since 1954)

INCIDENT NOTICE

INCIDENT TITLE: **Repeated poor-shaped crystals generated and manually handled in Lead Azide precipitation process**

DATE POSTED 22 November 2023	REFERENCE IN 23-09	SOURCE Orica
INCIDENT OUTLINE		
When did it happen?	April to August 2023	
Who experienced it?	Orica	
Where did it happen?	Lorena, Brasil	
What material was involved?	Lead Azide	
What happened?	<p>Over a period of several months, lead azide would occasionally be manufactured with poor (undesirable) crystal structures (typically rods and stars). The crystals were observed by the process operator, and material was drained from the reactor and taken to a magazine for storage prior to destruction. The handling of poor lead azide crystals exposes an operator directly to a major hazard.</p> <p>In total, approximately 20 batches were manufactured during this time which did not meet an appropriate safety specification for safe handling.</p> <p>No initiation occurred as part of these events, no injuries to personnel involved.</p>	
Why did it happen – theory?	<p>Several factors led to these events, including:</p> <ul style="list-style-type: none">- Deviations from normal crystal

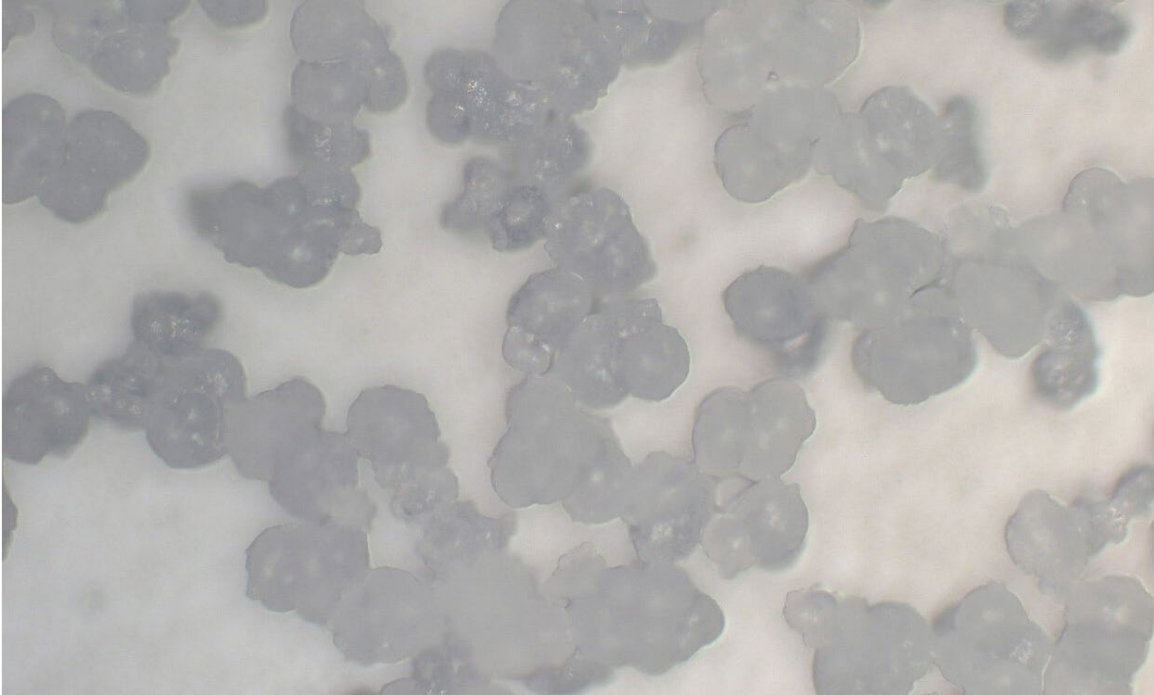
Good crystal structures are spherical (typical analysis from Lorena)

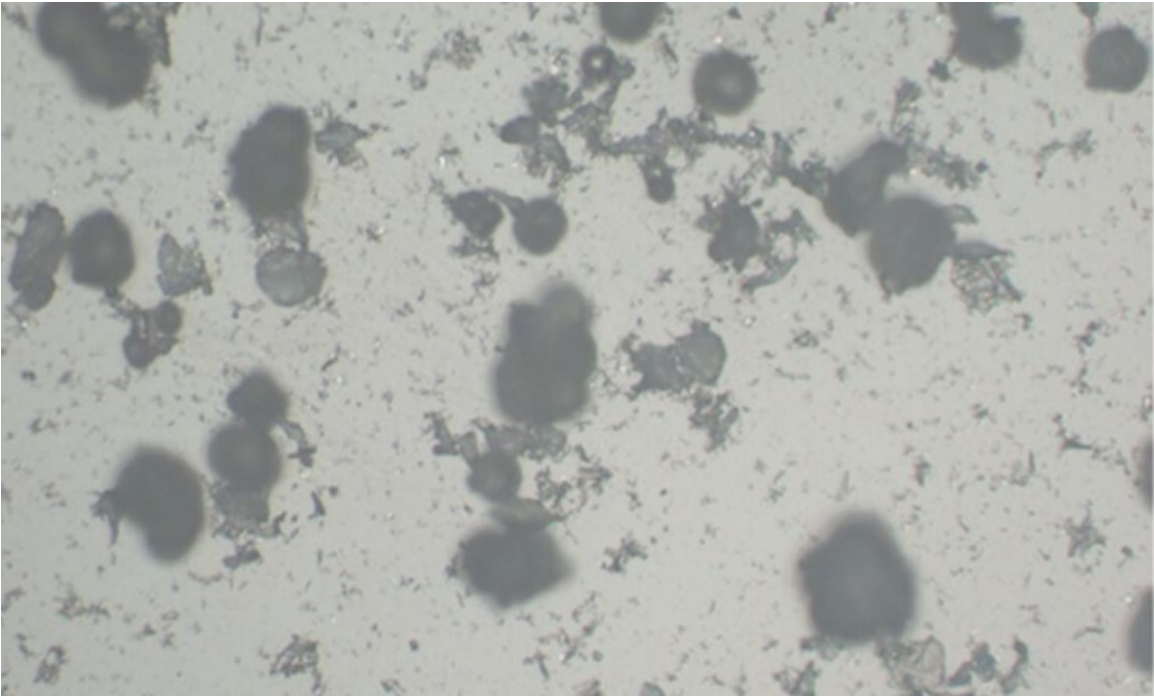
Example of poor crystal structures associated with these events

What was the impact?	Production stopped at the site. Corrective actions in process to address the above gaps. Plant will restart in the coming weeks.

Aside from resolution of the above noted technical issues, organisational factors surrounding lead azide manufacture are critical to ensure safety of operations personnel. Teams should be enabled to stop processes and escalate when abnormal scenarios occur, prioritise resolution of process issues and restart safely.
