SAFEX
INTERNATIONAL
(Since 1954)

INCIDENT NOTICE

INCIDENT TITLE: **Deflagration of pyrotechnic composition during rigid element filling**

DATE POSTED 22 November 2023	REFERENCE IN 23-10	SOURCE Orica
INCIDENT OUTLINE		
When did it happen?	18 September 2023	
Who experienced it?	Orica	
Where did it happen?	Lurin, Peru	
What material was involved?	Pyrotechnics	
What happened?	<p>During filling of 10mm rigid elements, some of the aluminium shells were becoming stuck and damaged in the machine guides.</p> <p>These shells were then filled with pyrotechnic composition and pressed. As a result of the deflagration, a significant amount of energy was vented laterally, resulting in the doors of the machine blowing out. There were 5 operators in the room at the time of the event. All operators evacuated and were unharmed.</p>	
Why did it happen – theory?	<p>The likely immediate cause of the event was a friction initiation of the pyrotechnic compound during pressing. This resulted in a deflagration which consumed 216 elements and 3 pots of pyrotechnic compound totalling approx. 2kg.</p> <p>Contributing factors included:</p> <ul style="list-style-type: none">- Damage of the aluminium shells du

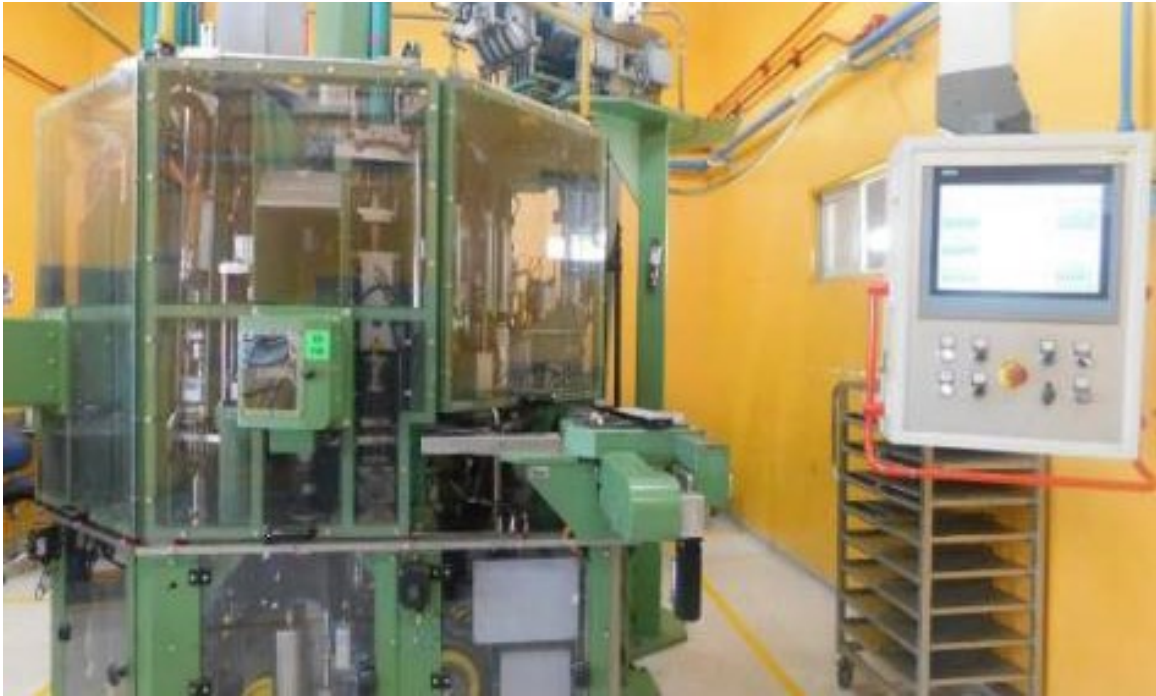
Element filling and pressing machine prior to the event

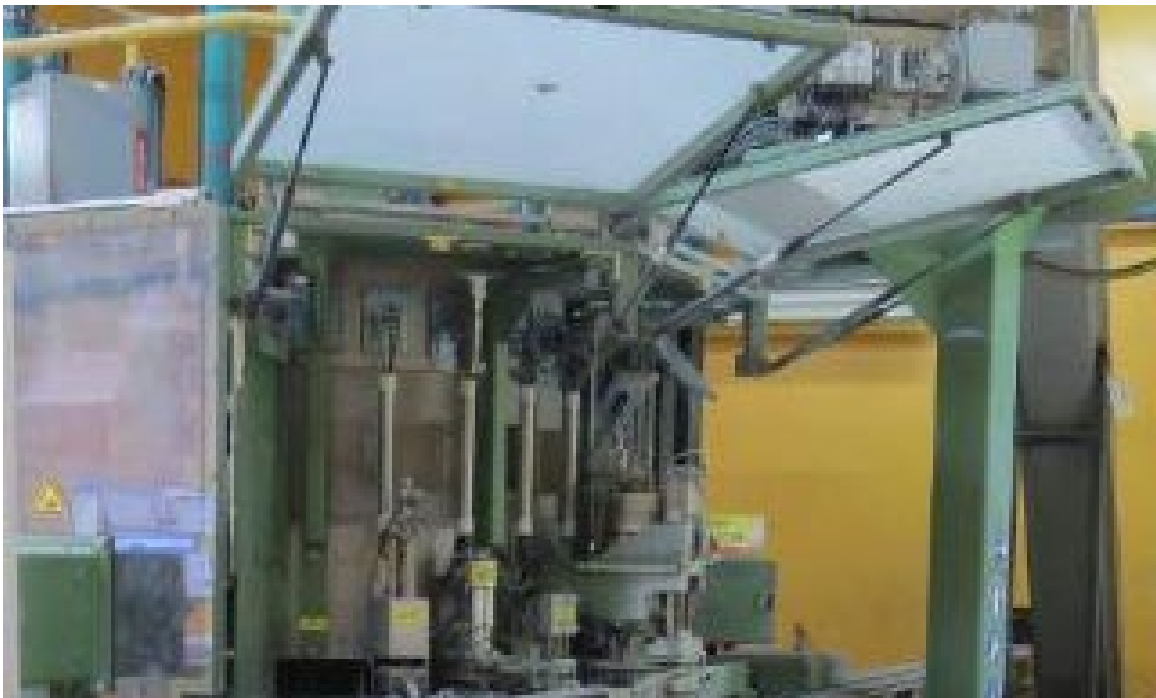
Element filling and pressing machine after the event

What was the impact?	<p>Production of 10mm elements has ceased on this machine.</p> <p>The pyrotechnic compound involved has been discontinued and substituted with a lower energy/sensitivity formulation, which gives the same performance but with an improved risk profile.</p>

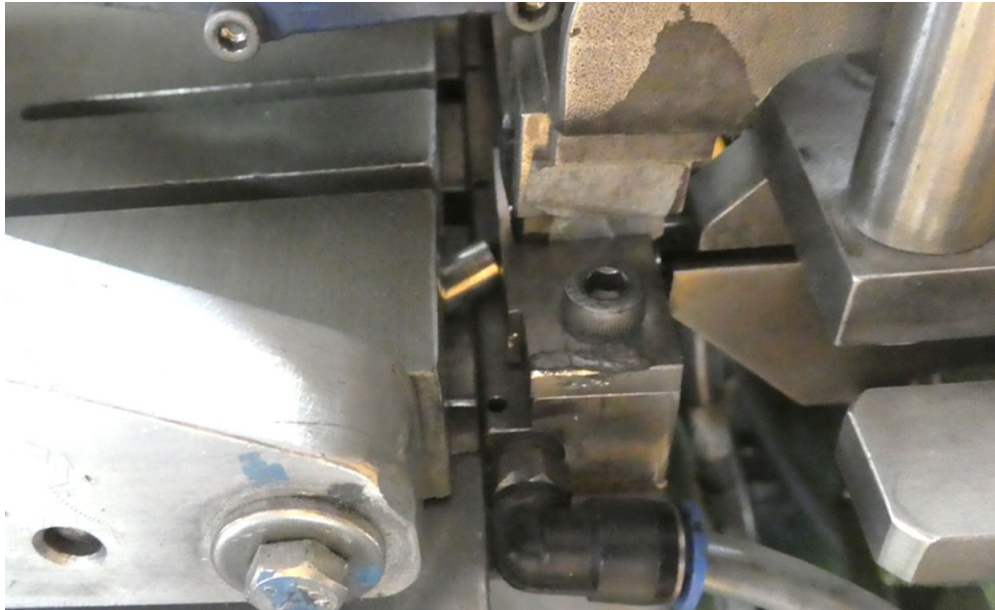
10mm elements would become stuck in the feeding chutes and dislodge

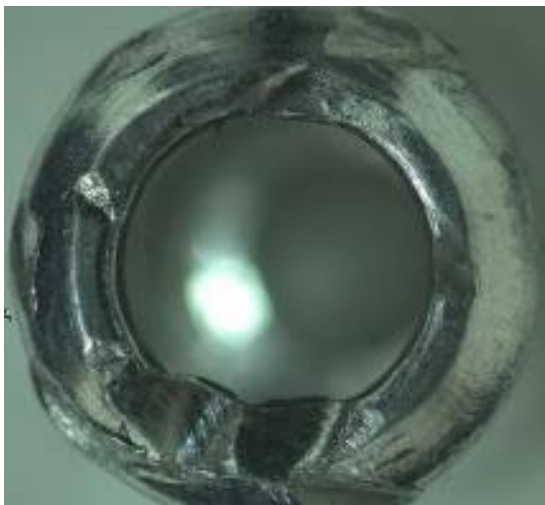
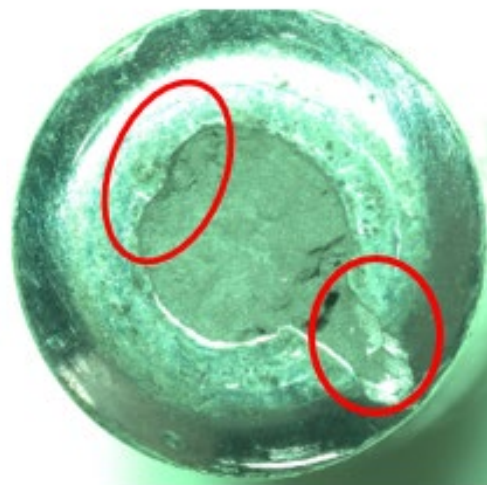
Examples of damaged elements
